Scholten GmbH's Wear Protection relaxes maintenance engineers:

Trouble-free cement production at Lägerdorf

Four weeks of revision for a trouble-free production

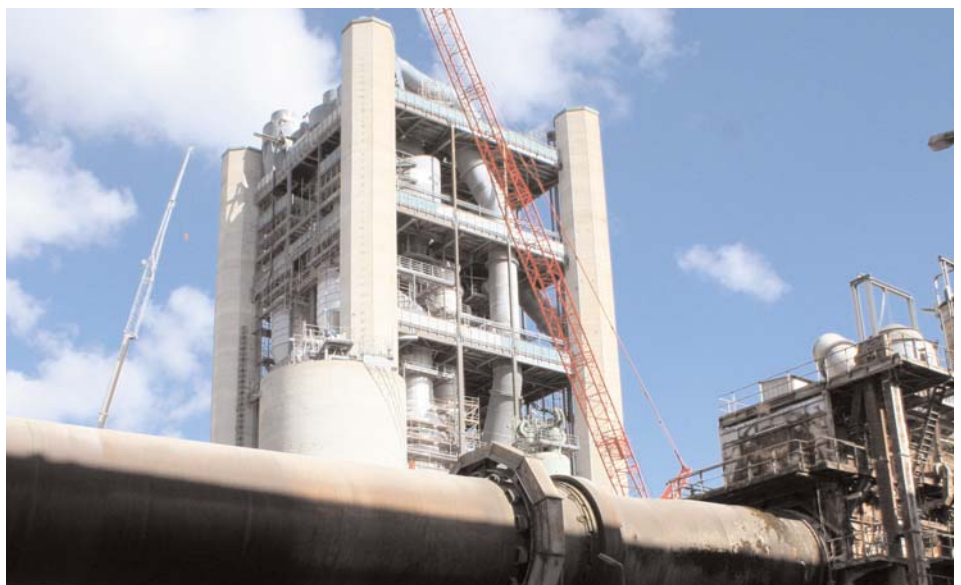
The riser dryer in the Lägerdorf plant has a height of 60 metres.

Integral fan mill, riser dryer pipes and cyclones are subjected to high wear. The hot raw mill transported at high speed would wear out unprotected walls within a very short time. Therefore, Holcim Lägerdorf has been successfully relying on wear protection solutions by the Wülfrath based Th. Scholten GmbH in this sector for more than eight years now. The riser dryer with its two riser pipes is around 80 metres high and has an inner

diameter of nearly three metres. The risers are completely lined with Scholten SC-WearStop material.

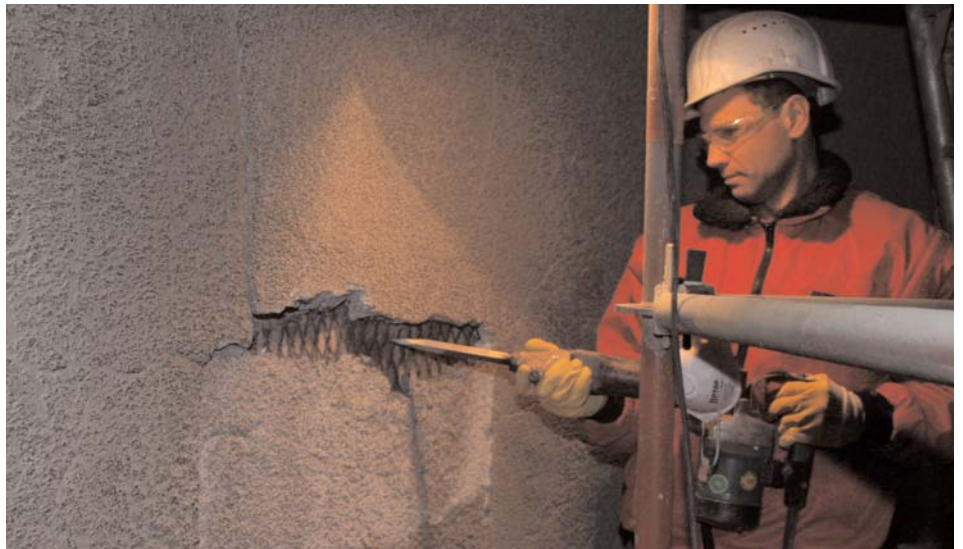
Individual and professional control and, if required, repair of the lining ensures a trouble-free production period for the operator (Foto: wed)

Scholten installation supervisor Karl Tomczak reports: "After nearly a year of production, the leftover layer of SC-WearStop was still in very good condition in many places, so that we only had to check for actually damaged areas and repair these."

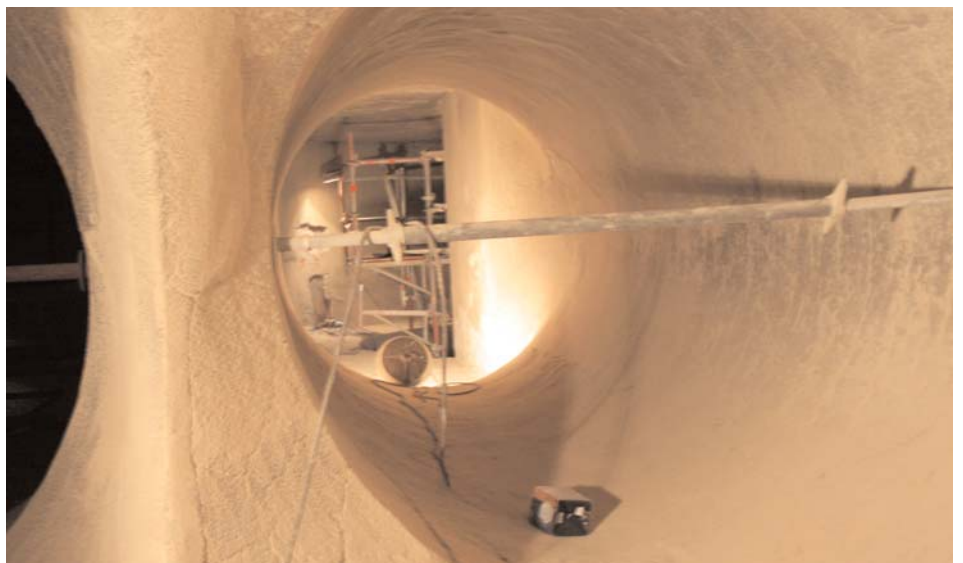
The riser dryer leading to the separator cyclones has a diameter of 2900 mm and is completely lined with SC-WearStop compound. (Foto: wed)

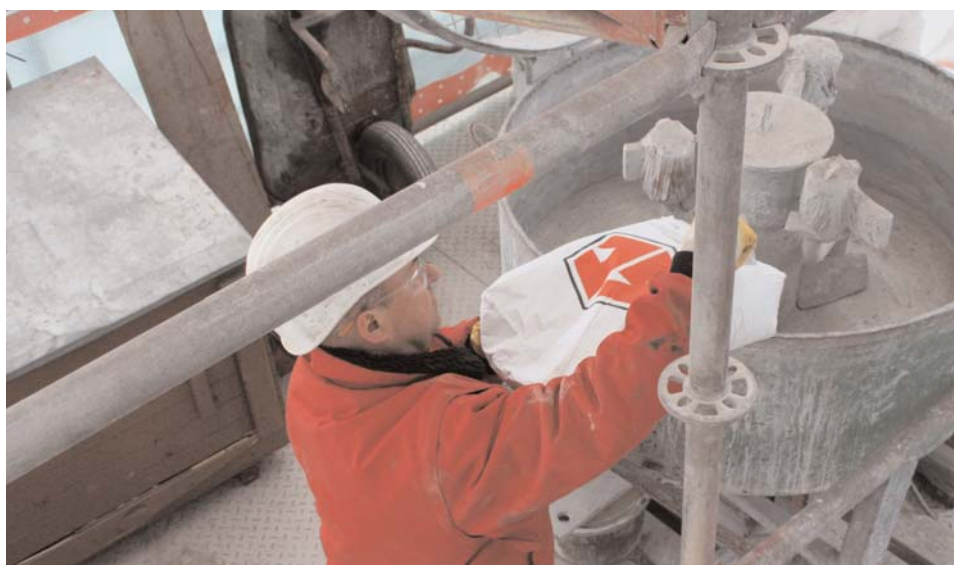
The SC-WearStop wear protection mortar is mixed up in a pan-pot mixer and manually applied by means of plastering trowel and finishing float. (Foto: wed)

Any new installation of SC-WearStop starts with the fixing of expanded metal, on which the pasty wear protection compound is applied as a 20 to 30 mm thick layer. For the recent revision in Lägerdorf, the riser dryer pipes and cyclones did not have to be replaced full-surface.

WearStop is available in different compositions and is applied selectively, depending on requirement. WearStop is one of many products being used as wear protection material.
